# **RESTORATION PLAN**

## **FOR THE MV *PAUL RUSS* SHIP GROUNDING (2014)**

**SAIPAN, COMMONWEALTH OF THE NORTHERN MARIANA ISLANDS**

**Final**  
**October 2025**

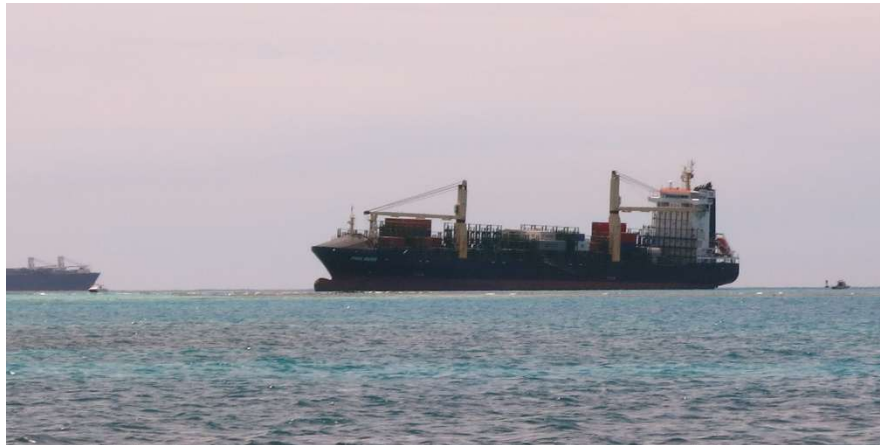
*Photo 1. the container ship, M/V Paul Russ, grounded on the reef in the Saipan Lagoon, tilted slightly, September 2014. Credit: CNMI CRI*

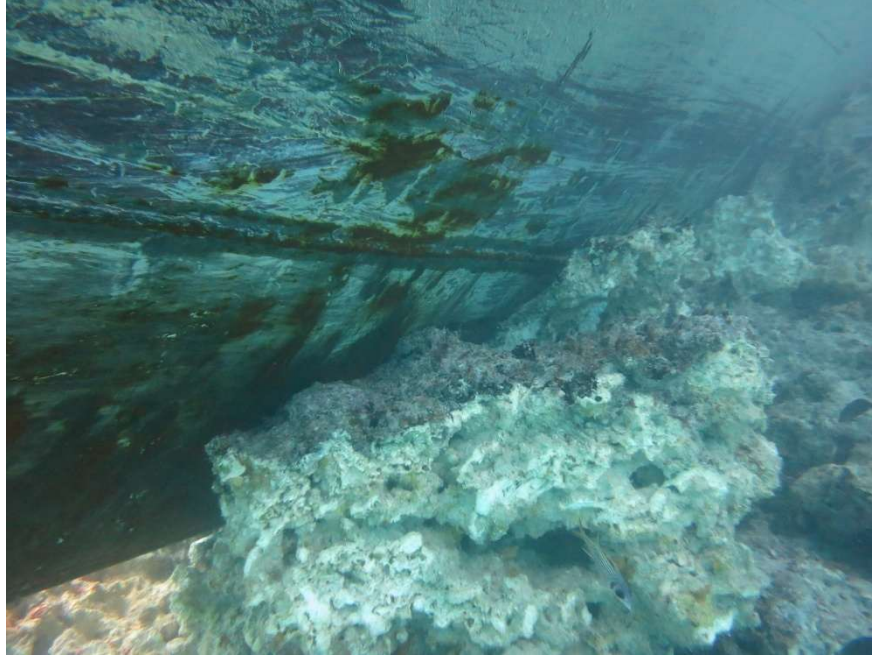
**Photo 2.** *The damaged hull of the M/V Paul Russ ship and damaged coral reef, September 2014. Credit: CNMI CRI.*

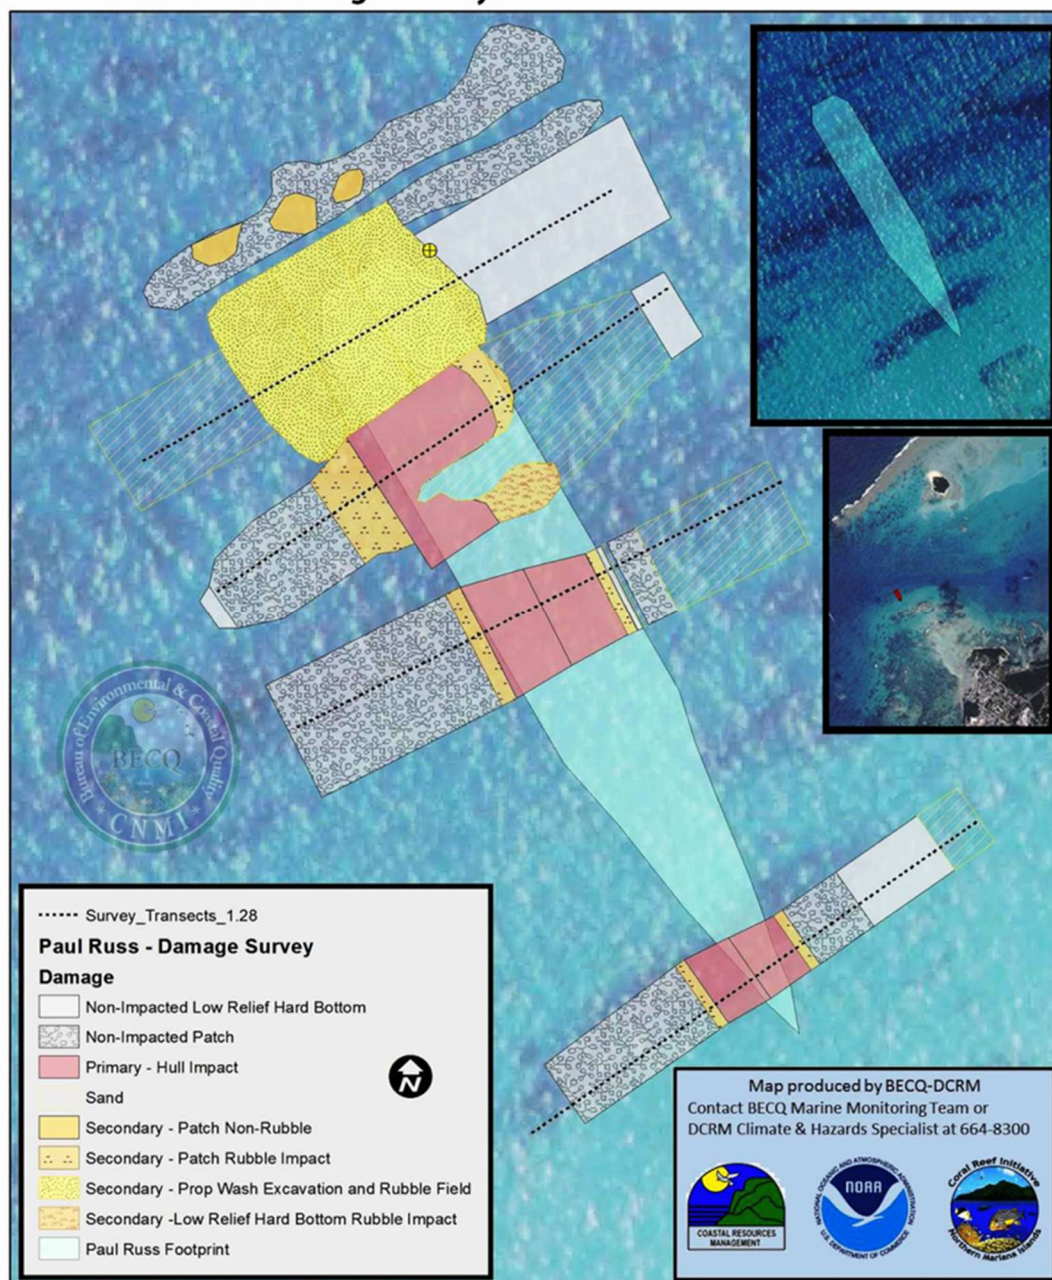
# **Paul Russ Grounding, September 2014 Transects & Damage Survey**

Figure 4. Paul Russ Grounding Transects and Damage Survey map, from Johnston et al. 2015. Provided by Steve McKagen, NOAA PIRO.

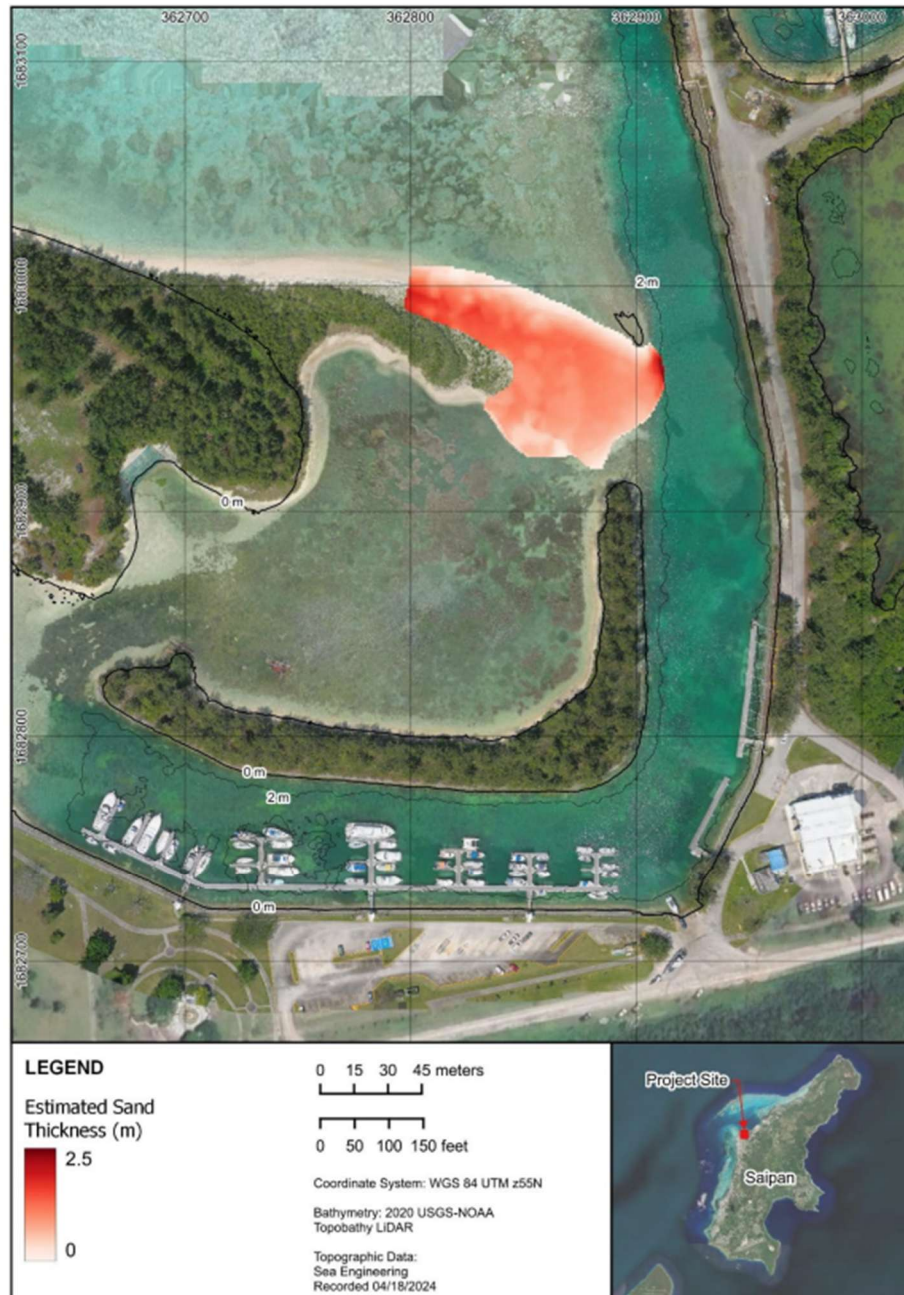
*Figure 6. Estimated sand thickness at the American Memorial Park/Smiling Cove Marina sand spit with the area estimated highlighted in shades of red. Figure 4-5 from the Saipan Lagoon Beach Restoration Feasibility Study, 2024. p. 43*

In conclusion, the Trustees propose to commit a majority of the Paul Russ Restoration Fund towards the Emergency Dredging of the Smiling Cove Marina sand spit, a volume of about 1,812 cubic meters of sand occupying a 2,716m<sup>2</sup> area, in order to adequately compensate the CNMI public for the interim loss of the resources at the time of the M.V. *Paul Russ* ship grounding in 2014, allowing room for possible changes in scope and circumstance of the dredging activities as they occur, as well as the inclusion of monitoring and adaptive management should the injured resource fail to meet expected recovery projections or as resources become available.

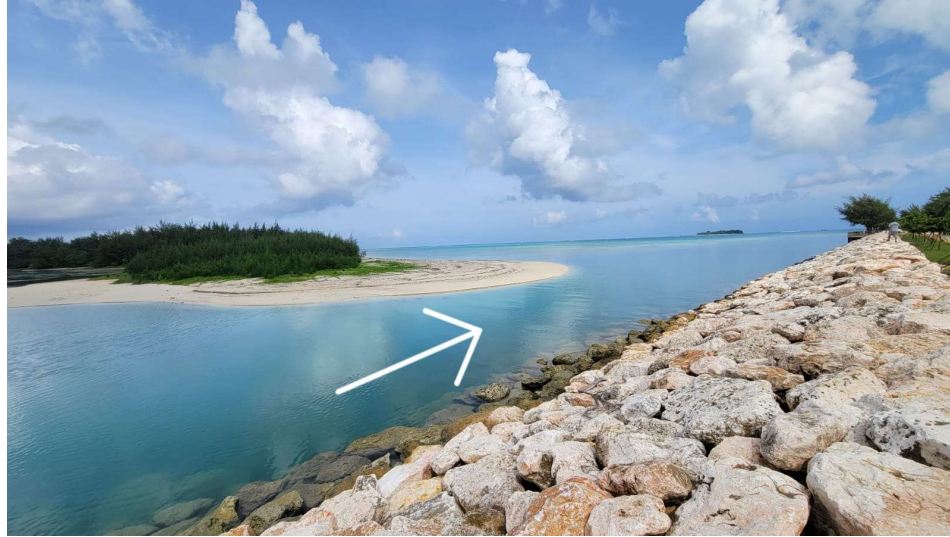
*Photo 10. a photo of the Smiling Cove Marina's current boating access channel taken in the middle of an outgoing tide, with a white arrow indicating the channel's width, September 2025. Credit: Kalani Reyes*

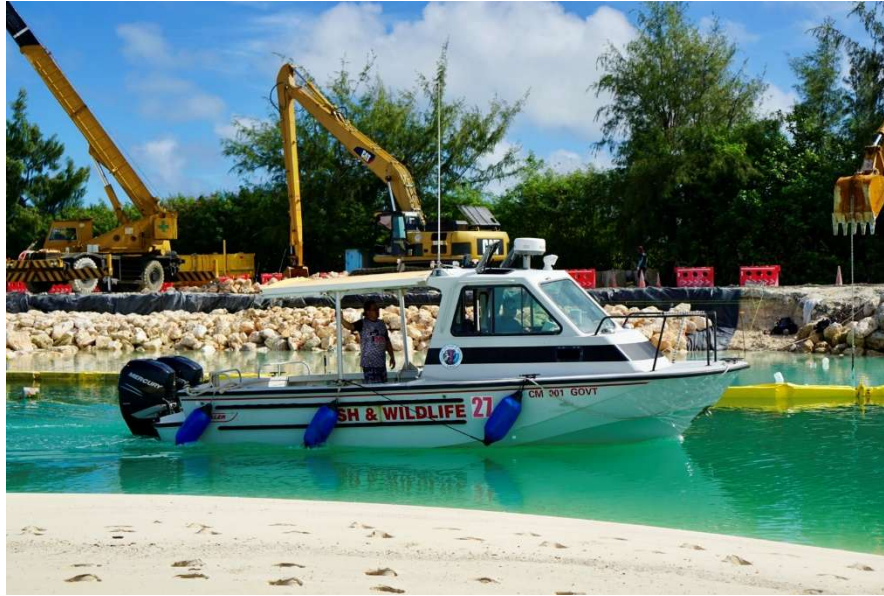
*Photo 11. A DFW Fisheries vessel enters the Smiling Cove Marina through what remains of the narrow boating channel access way during the construction activities of 2024, November 2024. Credit: Devon Lombard-Hensley.*

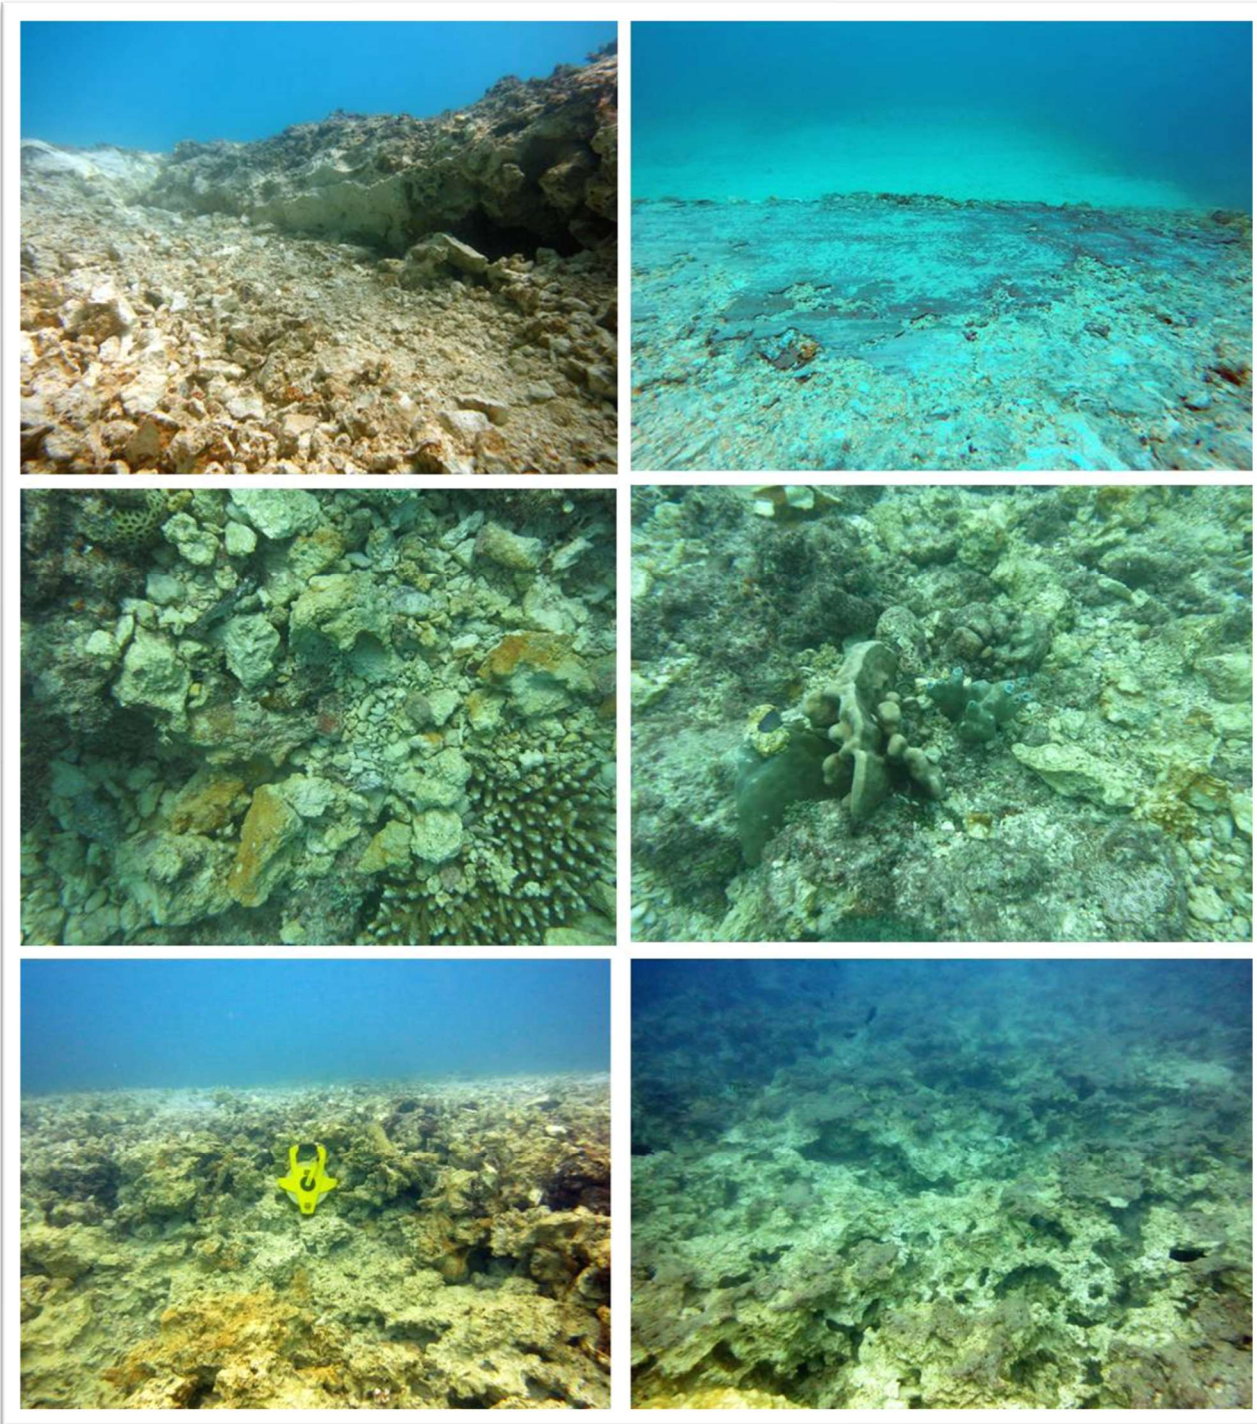
Figure xx. Examples of primary hull impact on patch reef habitat (PRHull; top), secondary rubble and debris impact on patch reef habitat (PRRub; middle), and secondary prop-wash impact on low-relief hard-bottom habitat (LRHProp; bottom). Hull paint is visible in the foreground of the top right photograph.

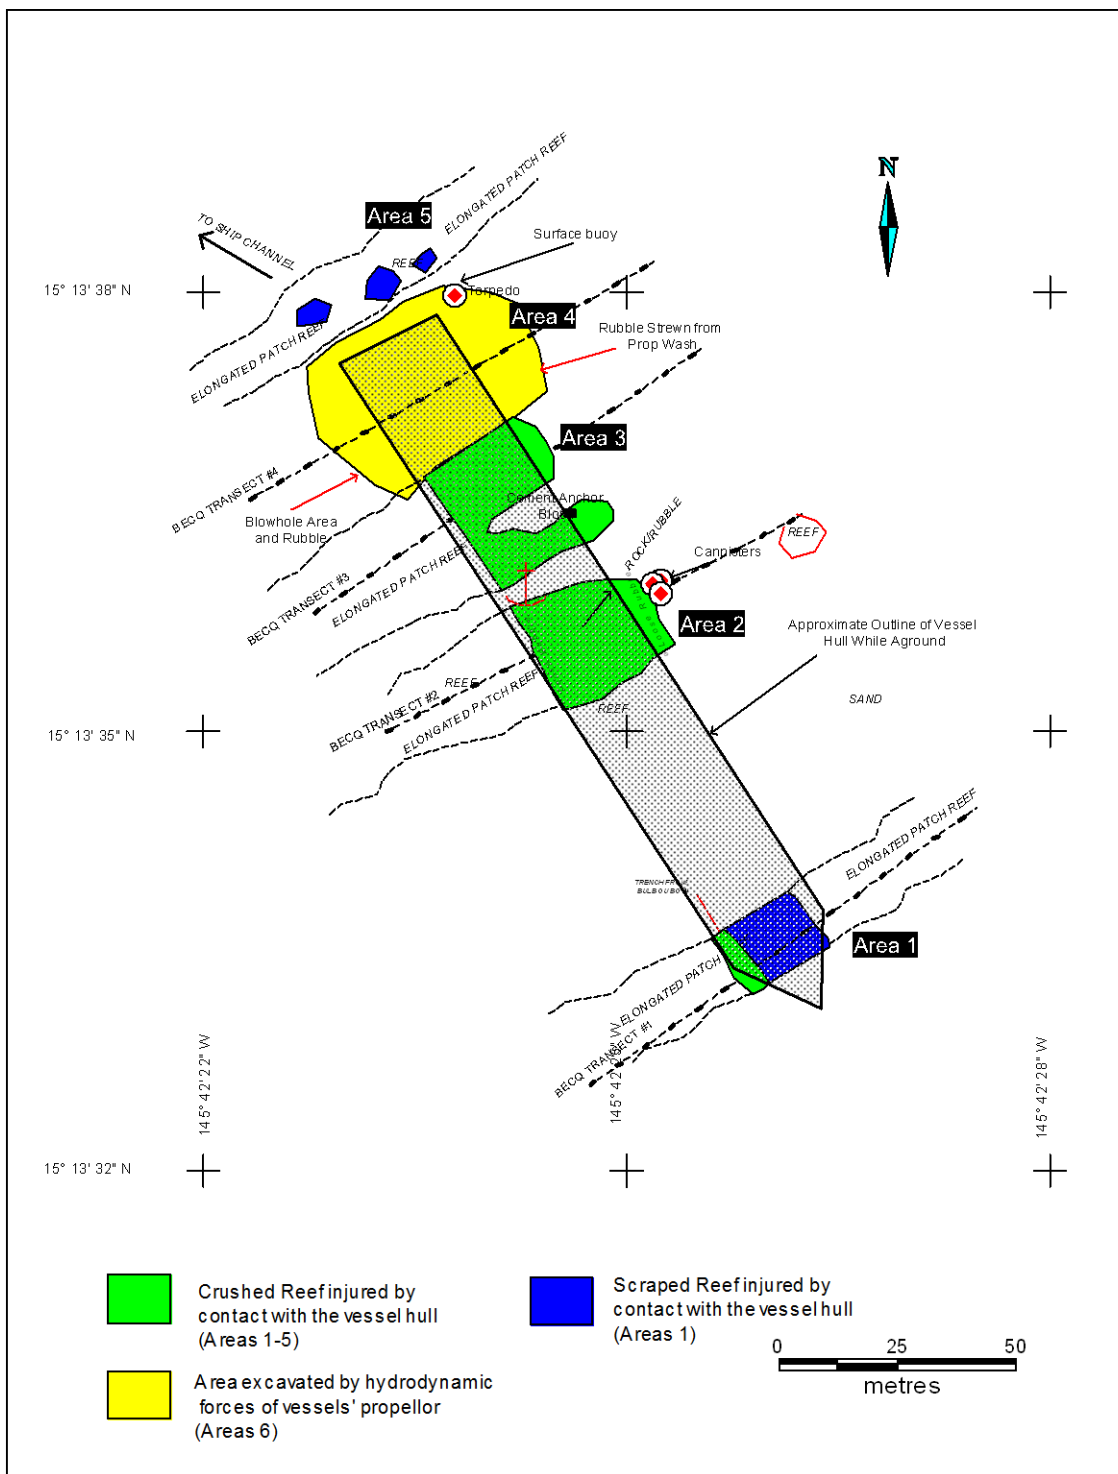
**Figure 1.** Injury types identified at the *M/V Paul Russ* grounding site.

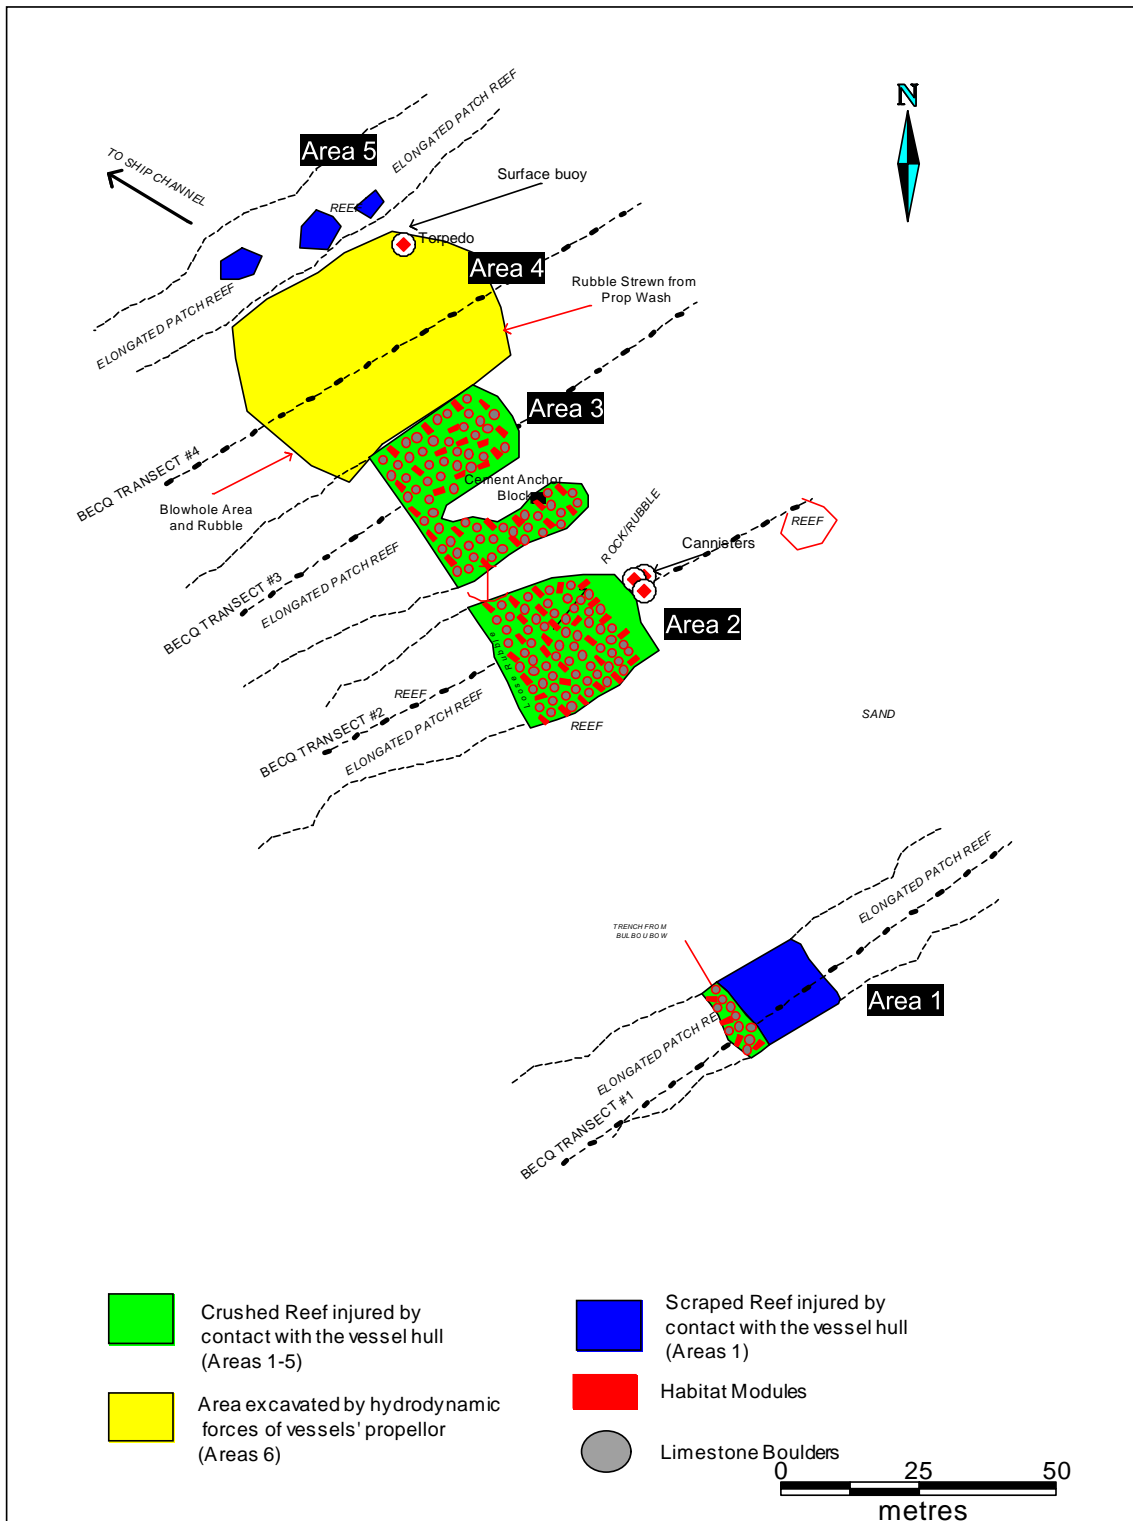
Figure 2. Location of proposed placement of habitat module and boulders at the M/V Paul Russ restoration site.

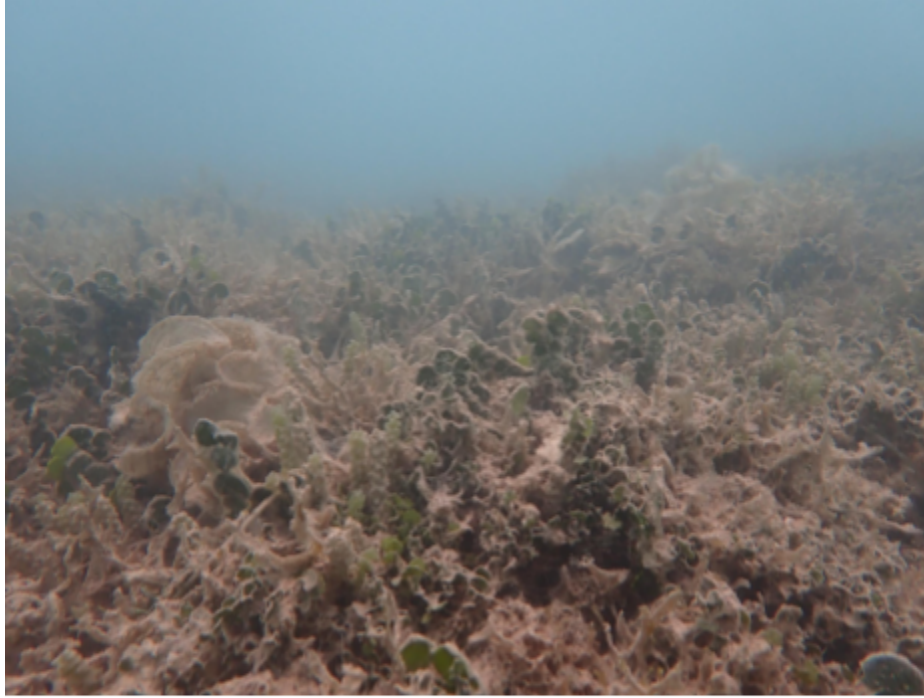
**Figure 2:** Thin mat of cyanobacteria covering the algae present in the area.
