# **RESTORATION PLAN**

## **FOR THE MV *PAUL RUSS* SHIP GROUNDING (2014)**

**SAIPAN, COMMONWEALTH OF THE NORTHERN MARIANA ISLANDS**

**Final**  
**October 2025**

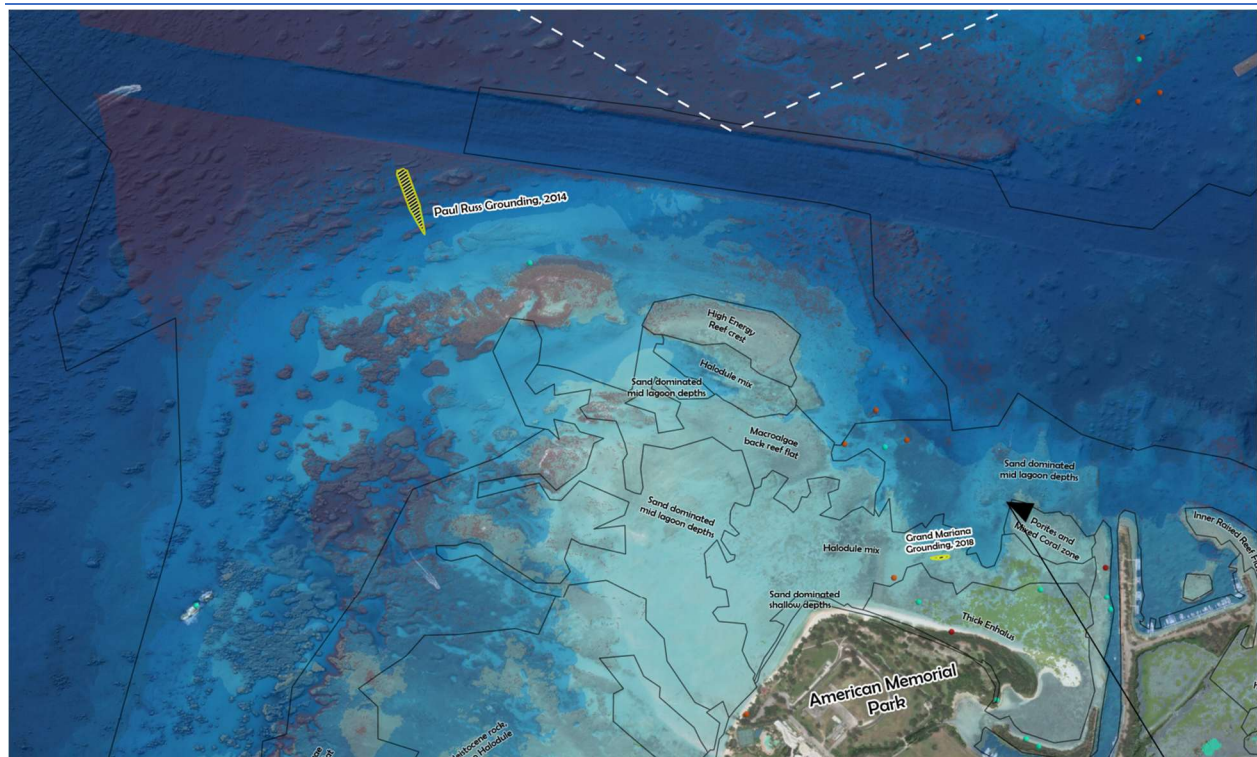
*Figure 1. Part of a bathymetry map of the Saipan shipping channel dredged area, with the location of the 2014 Paul Russ grounding highlighted in yellow above, just South of the channel. Further South East is the location of the Grand Mariana 2018 grounding also highlighted in yellow. Created by Robbie Greene, PCRP & DLNR, 2024.*

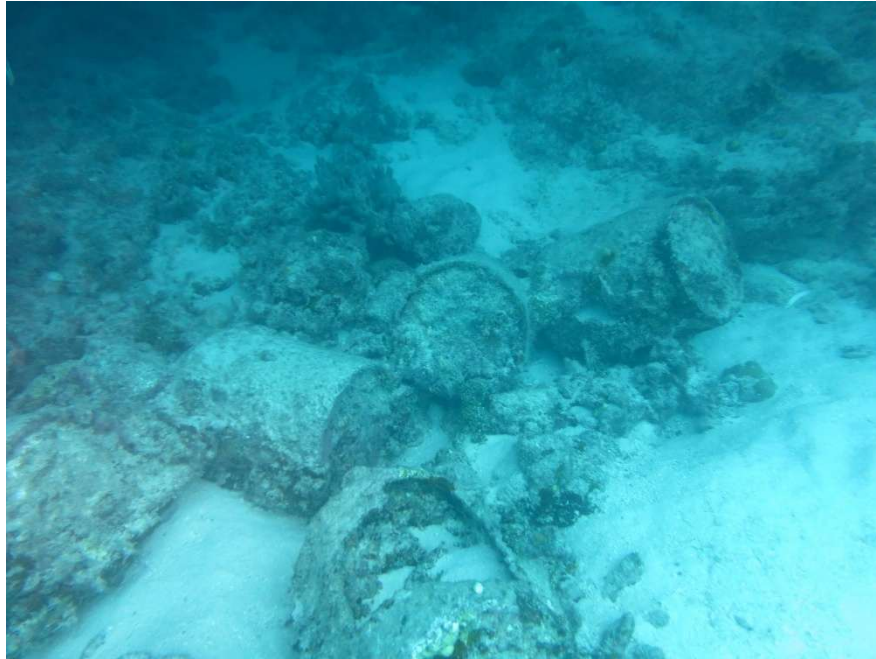
The geographic location and footprint of the ship were recorded using a handheld GPS unit from the surface. At that time, divers discovered potential unexploded ordnance on the seafloor near the grounded vessel, approximately mid-ship off the port side and at off the port side of the stern.

On September 11, the U.S. Navy Explosive Ordnance Division (USN EOD) arrived from Guam and conducted surface swims followed by an underwater assessment of the ordnance. The EOD determined that the ordnance were largely decayed and unlikely to come in contact with the hull of the ship during removal.

**Photo 2.** *Unexploded ordnance from WWII discovered in the near vicinity of the grounding site, September 2014.*  
*Credit: CNMI CRI*

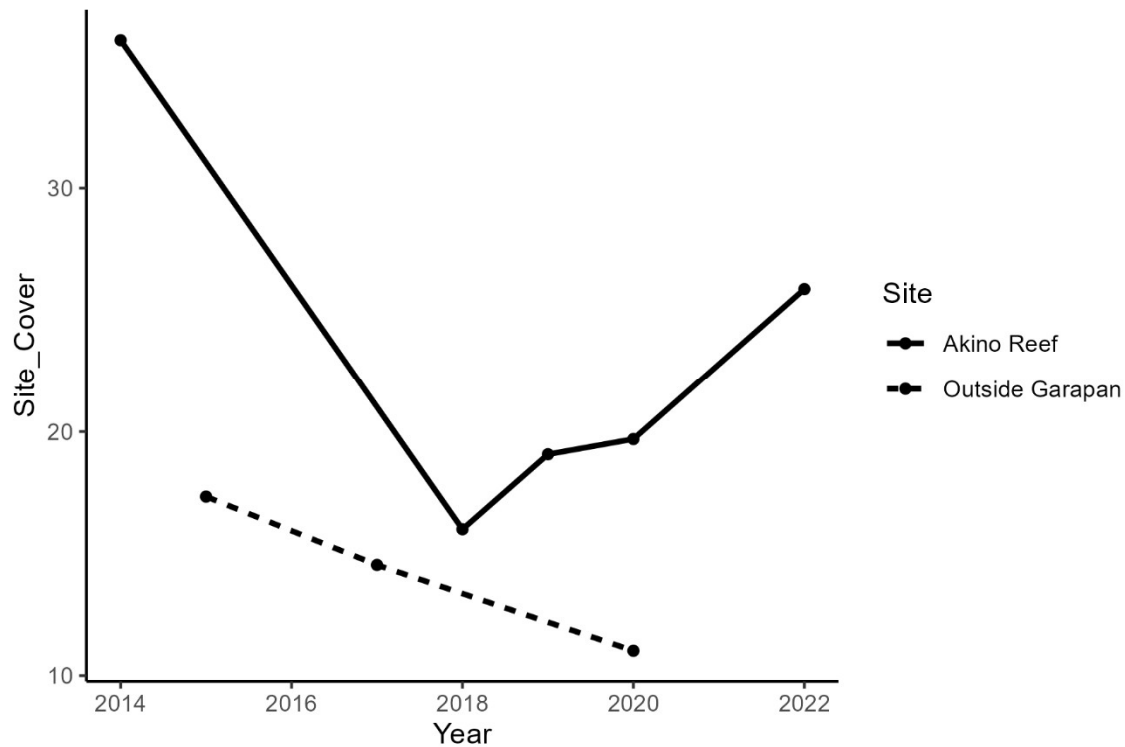
Data on coral cover near the two long term marine monitoring sites monitored by the Coral Reef Initiative's Long Term Marine Monitoring Team in the area was observed to have experienced a marked decline since the 2014 grounding (MMT Data, 2025), however some coral cover recovery was also observed to be on the rise since after the 2017 coral bleaching event, as evidenced by Figure 5 below.

Figure 5. Benthic coral cover percentage from two nearest sites to the Paul Russ Grounding, Akino Reef and Outside Garapan Reef. The graph clearly shows a marked decline in coral cover percentage. Provided by Frank Villagomez and the CNMI MMT, 2025.

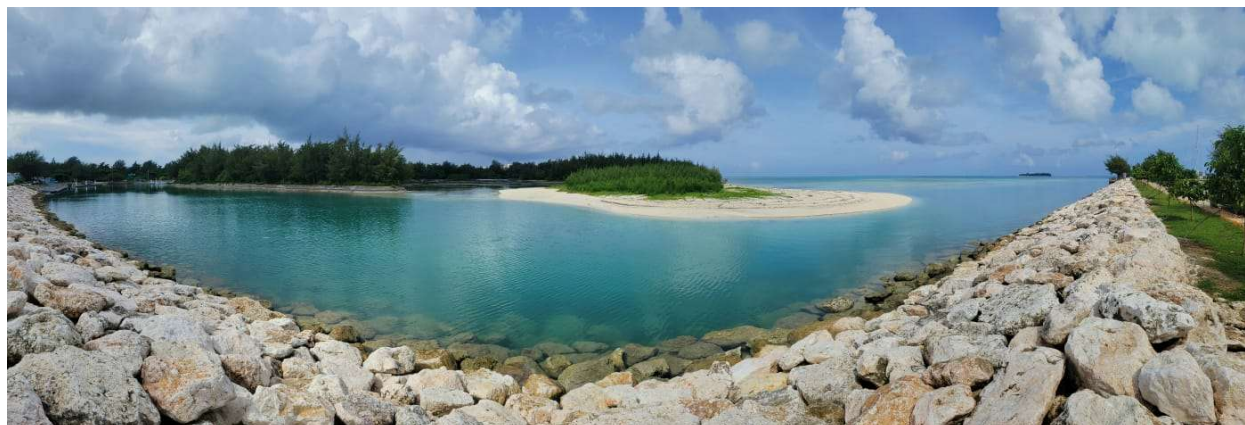
*Photo 7. a panoramic view of the Smiling Cove Marina's current boating access pathway to the Garapan Lagoon, September 2025. Credit: Kalani Reyes.*

Smiling Cove Marina's Sand Spit Emergency Dredging activities have been identified as a priority action for the CNMI. The following table addresses each criterion against a No Action Alternative.

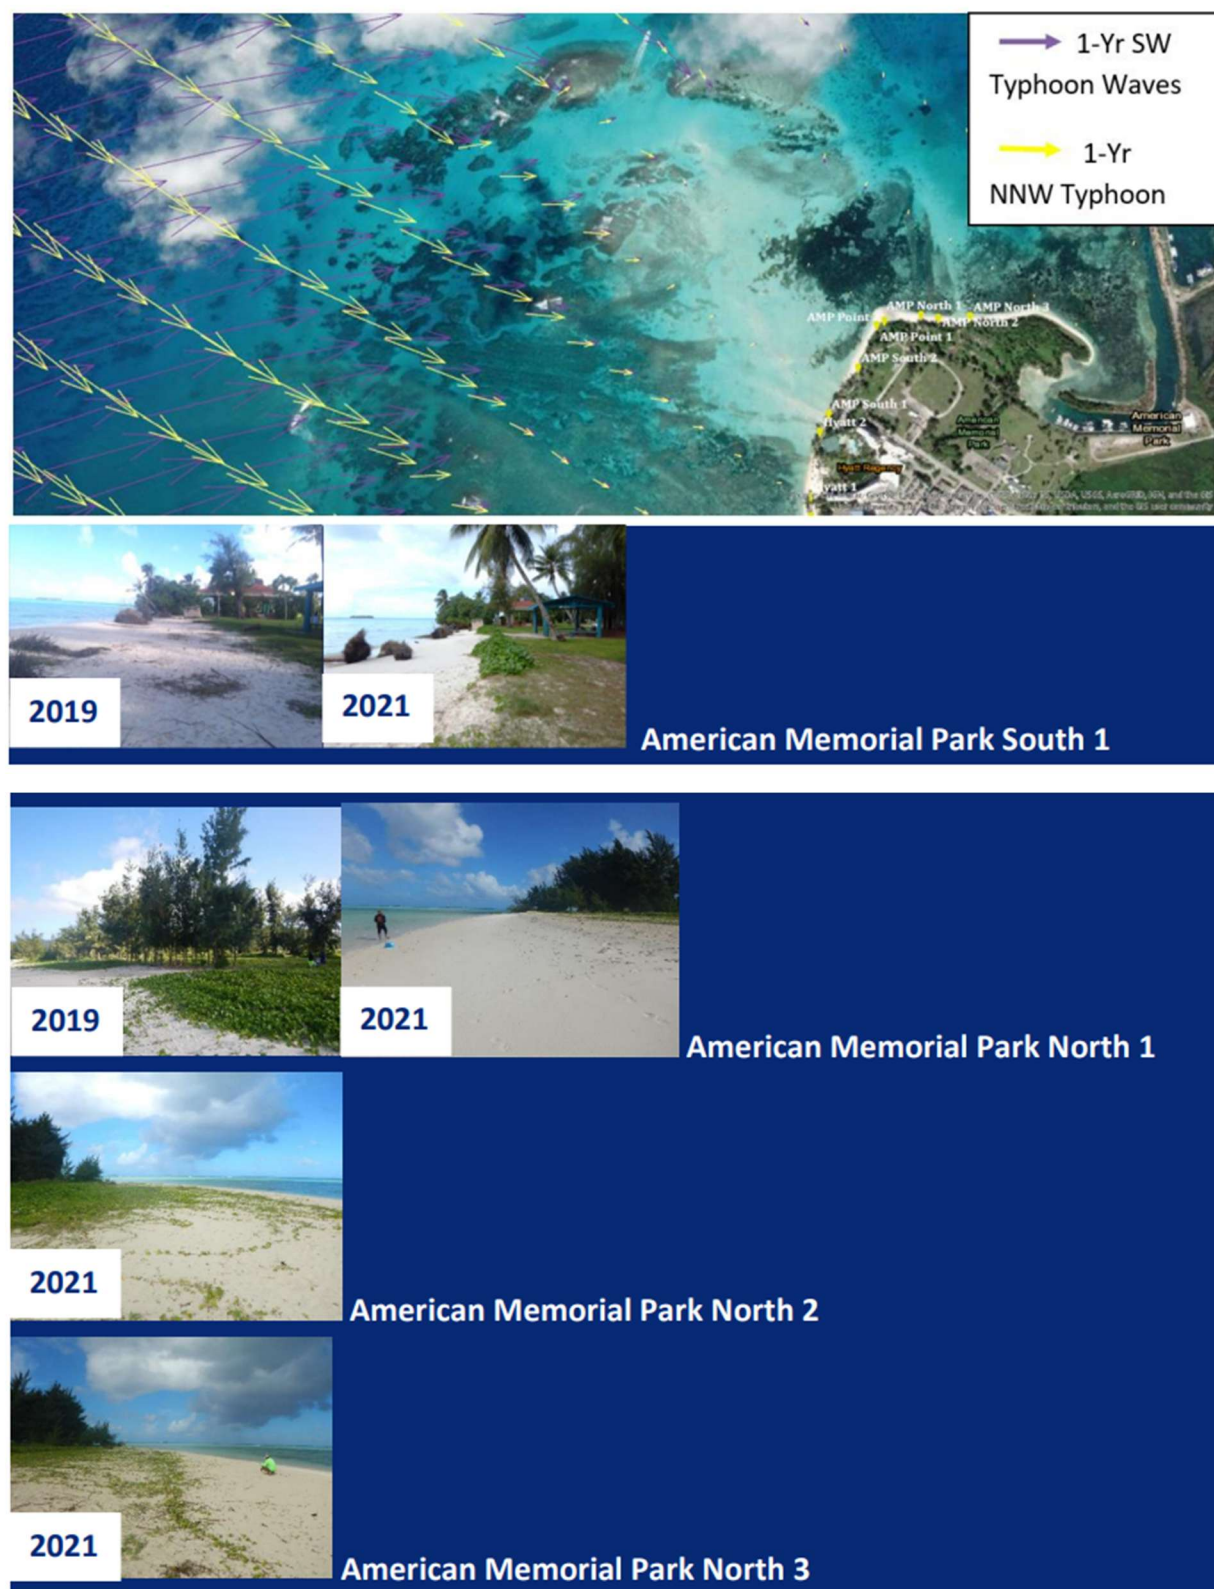
Figure 7. Profile of the AMP South 1 and North sites with yellow arrows showing typhoon wave direction, from DCRM's Shoreline Monitoring Beach Profile Report for Saipan and Mañagaha, 2022. p.69-70. BECQ 2022.

The report concluded that the AMP North transects (within the National Park Service vicinity) received sand deposition from ongoing longshore transport process. Sand migration from the south of AMP to the northern area facing Smiling Cove was evident after the September 2021 storm. This sand build-up to the North of the AMP North 3 shoreline, also referred to as the Smiling Cove Sand Spit, has been found to smother sensitive *Enhalus* seagrass habitat holding the remaining sand and sediment in place, and has negatively affected the coral reef, mangrove, and sand ecosystems in the nearby area. A study in 2016 found that together, live corals, seagrasses, and mangroves supply more protection services than any individual habitat or any combination of two habitats (Guannel, et al. 2016). This further emphasizes the need to address this issue of the SCM sand spit otherwise the CNMI will further lose out on these ecosystems.

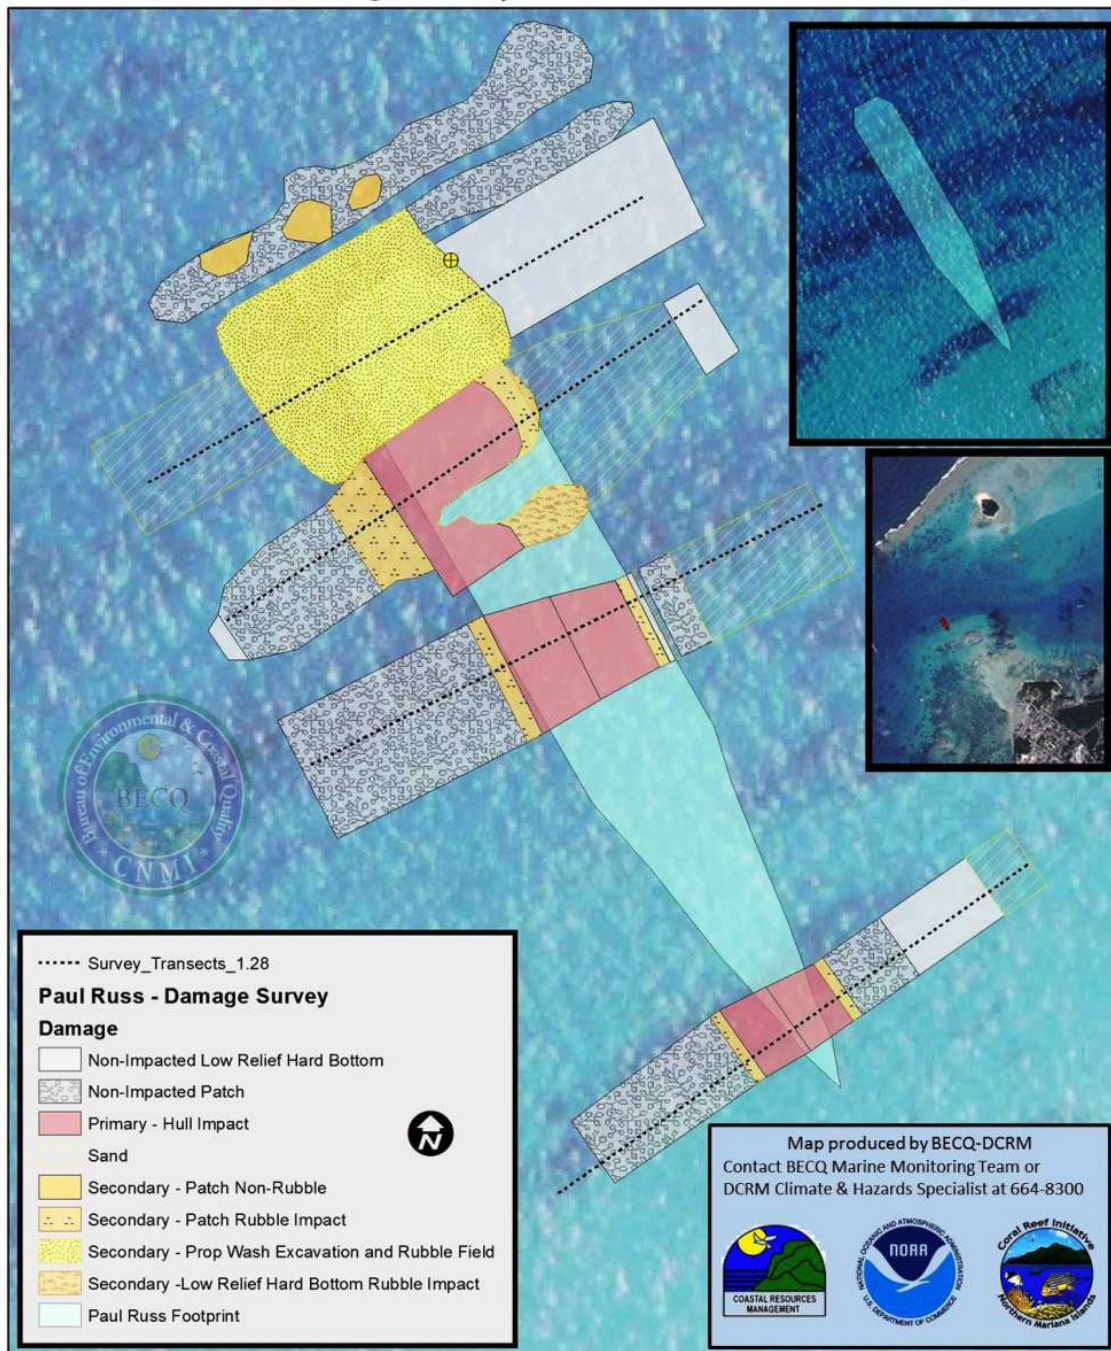
Figure 1 Location of the M/V Paul Russ ship grounding in the Saipan Lagoon (inset) and impact area map

Three distinct injury types were identified within the affected area including: crushed reef, scraped reef, and blowhole and rubble areas (**Figure 1**). Based on results of the injury assessment survey, approximately 3,000 m<sup>2</sup> of coral reef was immediately affected by the grounding. However, it is possible that the spatial extent of this injury area, as well as the natural resource damages associated with these injuries, can change depending upon what rehabilitation actions are subsequently pursued or neglected.

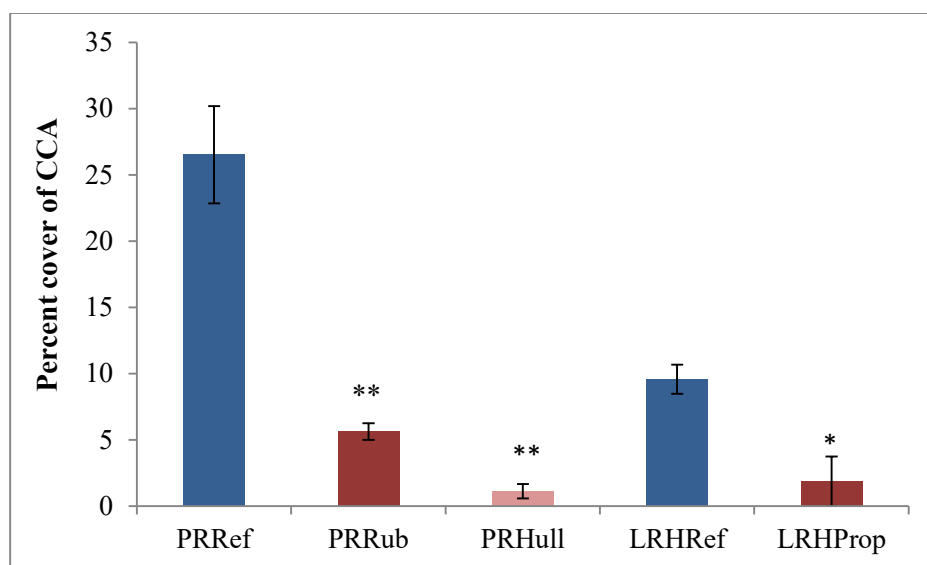
**Figure xx.** Percent cover of CCA for HabitatxImpact groups. Asterisks indicate a significant difference in pair-wise comparisons between impact and reference areas (\*\* $p < 0.01$ ; \* $p < 0.05$ ).

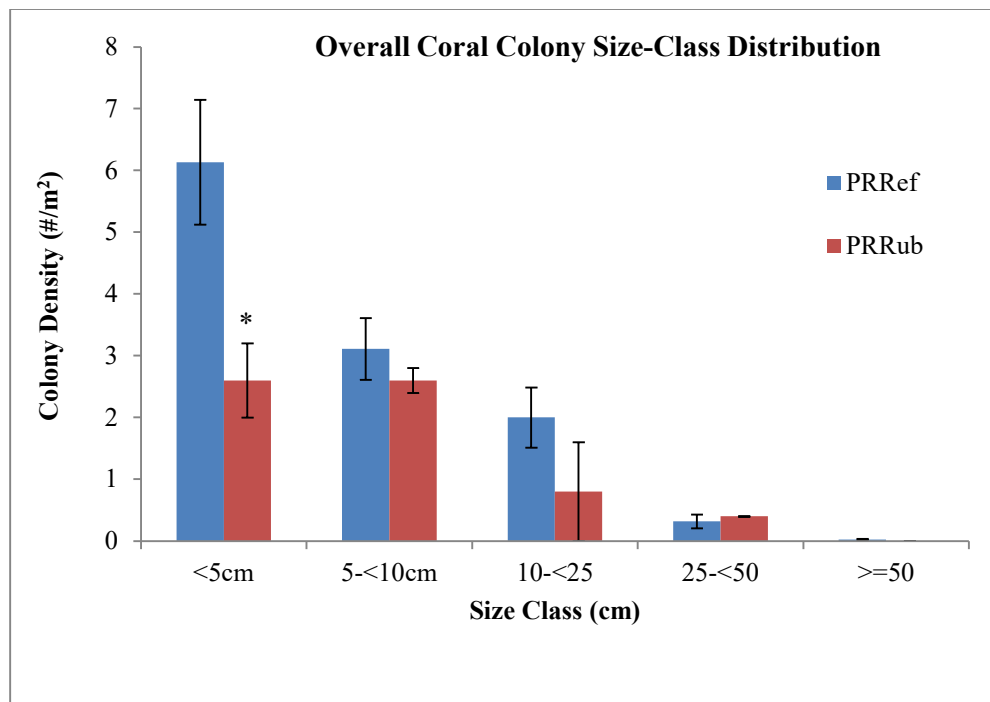
Fig xx. Overall coral colony size-class distribution (means  $\pm$ SE) for non-impacted patch reef reference areas (PRRef) and patch reef areas impacted by grounding generated rubble and debris (PRRub). There was a significant difference in the density of small (<5cm) colonies between PRRef and PRRub (t-test;  $P=0.09$ )
